Midwest Home and Property Inspection
Quality Inspections at Affordable Prices

CONFIDENTIAL INSPECTION REPORT

1234 Any Street
Kansas City, MO 64155

09/27/2017

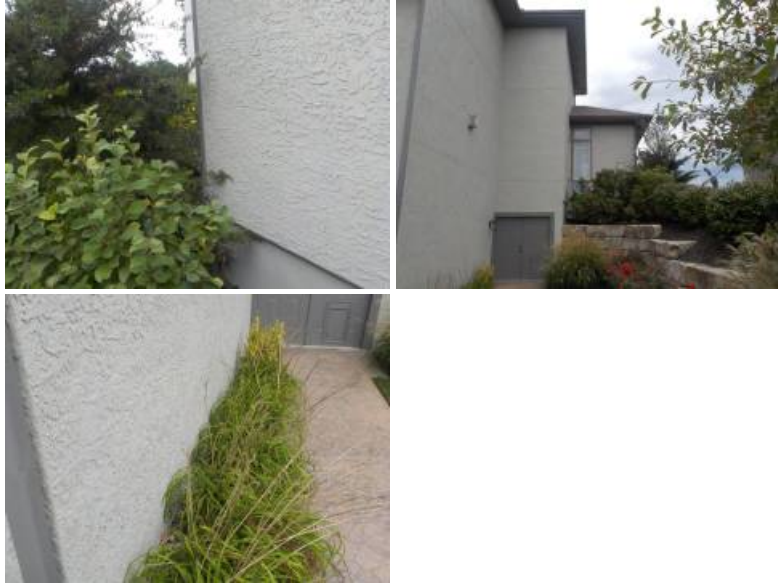
Shrubs or other vegetation is encroaching on the structure, and should be kept a minimum of twelve inches away for the general welfare of the walls and foundation.

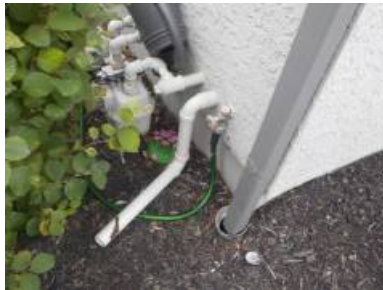
The sump pump discharge pipe should be extended to help direct the water farther away from the foundation.

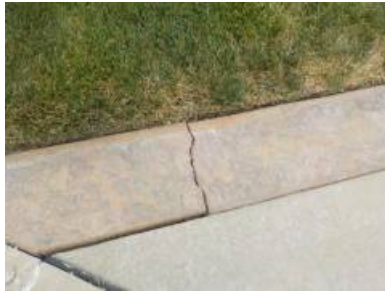
Driveway Conditions: There are common cracks in the driveway.

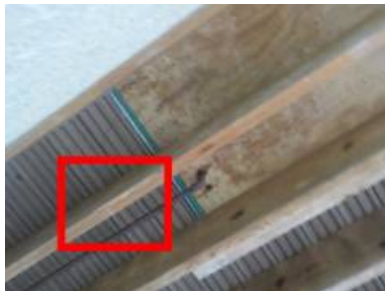
Screened in Deck: One of the deck joist is broken, Recommend replacement by a certified contractor.

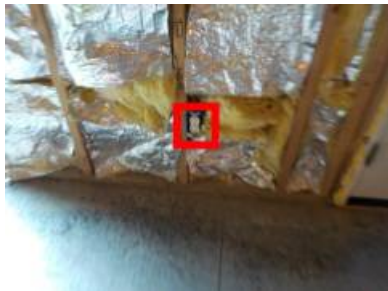
Outlets: An outlet is missing a cover plate which can be a safety concern and should be installed.

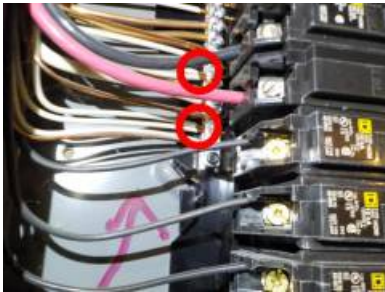
Wiring Observations: Standard wiring methods call for one current carrying conductor per lug on the neutral bar in the main panel. The 100 amp panel in the basement has multiple neutrals under common lugs. This should be corrected by a qualified electrician.

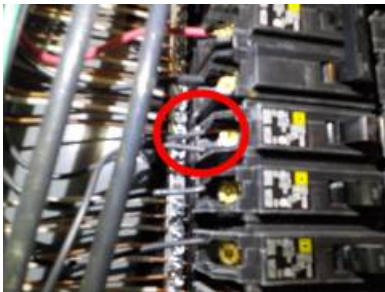
Circuit Breakers: A breaker in the 200 amp panel is serving two circuits (double tapped), which could overload the circuit. This condition should be evaluated by an electrician.

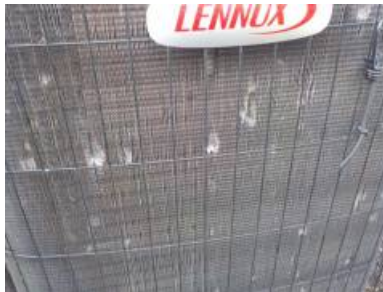
Condensing Coil Condition: Some of the condensing coil fins are bent. This reduces the air flow across the coil. Recommend having a fin comb ran through the fins. This will straighten out the fins and increase the air flow across the coil and help with the cooling process.

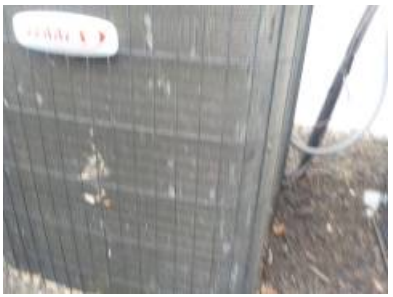
Condensing Coil Condition: **Some of the condensing coil fins are bent. This reduces the air flow across the coil. Recommend having a fin comb ran through the fins. This will straighten out the fins and increase the air flow across the coil and help with the cooling process.**

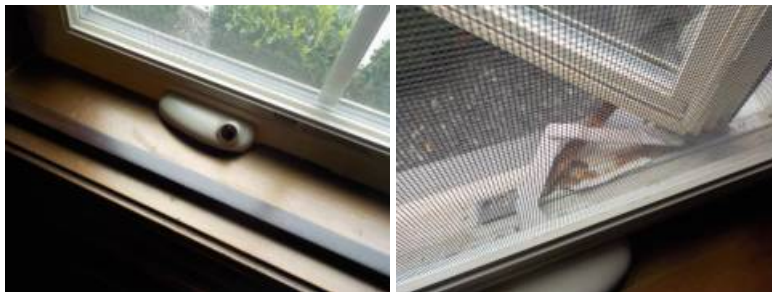
Window Conditions: **The crank mechanism on one of the windows is broken and could not be inspected and the hinge on the other window is rusted and should be replaced.**

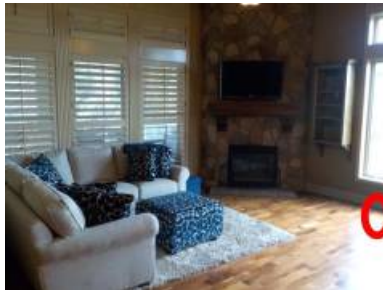
There is an area of the wood flooring that has been water damaged by the possible leaking window. Recommend repairs by a certified contractor.

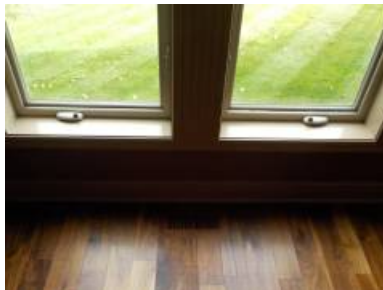
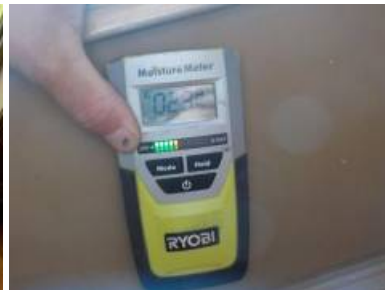
There are two windows that the crank mechanisms are broken and should be repaired or replaced. There is also one window that has been sealed with puddy. The wall directly below this window has a moisture reading of 29%. Recommend evaluation and repairs by a certified contractor.

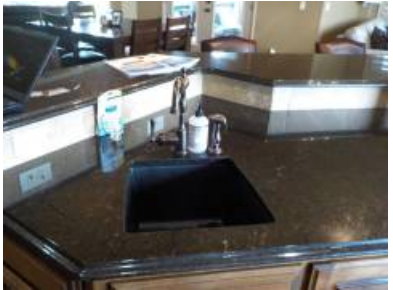
Sink(s) and Drainage: **The small sink faucet is noisy and has low water pressure when turned on full. Recommend evaluation and repairs by a certified contractor.**

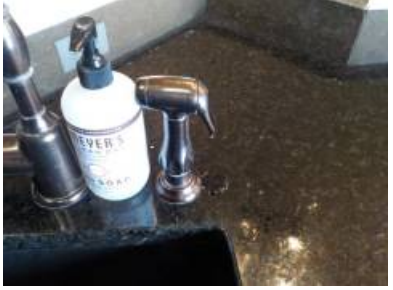
Hand Sprayer **The hand sprayer to the small sink leaks and should be repaired or replaced.**

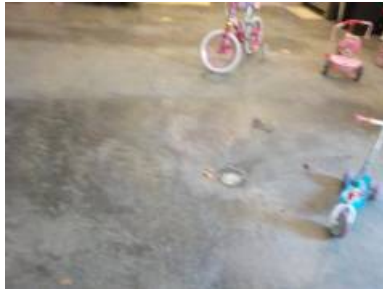
Slab Floor The slab floor is cracked. Such cracks are common and result as a consequence of the curing process, seismic activity, ordinary settling, or the presence of expansive soils and are not structural concerns.

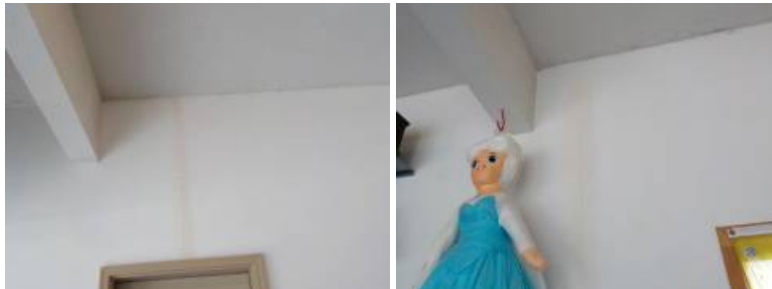
Walls and Ceiling: The walls and or ceiling have stress fractures, which have resulted from movement. Recommend continued evaluation and repairs as needed by a certified contractor.
