Midwest Home and Property Inspection
Quality Inspections at Affordable Prices

CONFIDENTIAL INSPECTION REPORT

1234 Any Street
Kansas City, MO 64155

09/27/2017

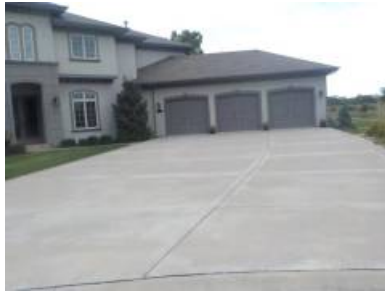
Driveway Conditions: There are common cracks in the driveway.

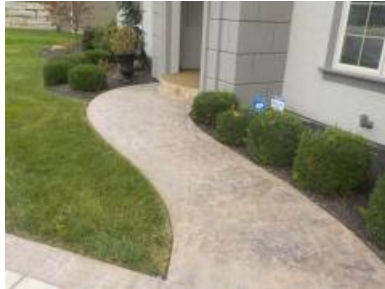
Walkway/Stoop Conditions: The walkways are acceptable.

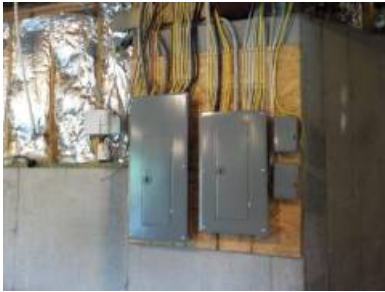
Main Panel Observations: The panel and its components have no visible deficiencies.

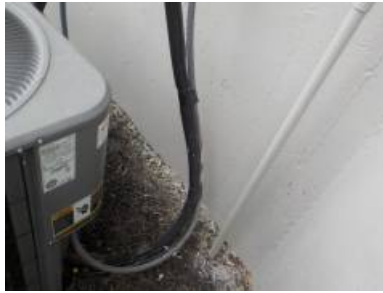
Condenser Clear of Obstruction: Obstruction, such as vegetation, within 4' of the cabinet could interfere with airflow around the cabinet. This can affect the efficiency of the unit.

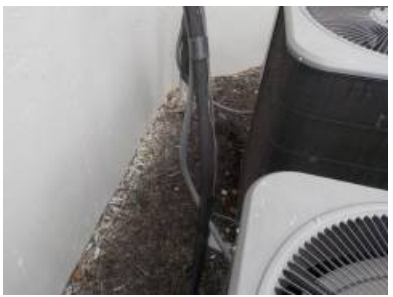
Condenser Clear of Obstruction: **Obstruction, such as vegetation, within 4' of the cabinet could interfere with airflow around the cabinet. This can affect the efficiency of the unit.**

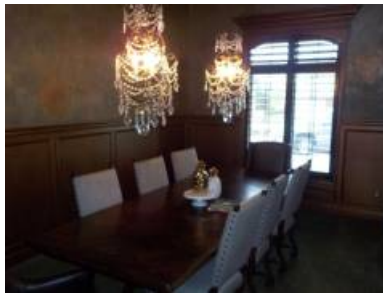
Dining Room

Window Conditions: **The crank mechanism on one of the windows is broken and could not be inspected and the hinge on the other window is rusted and should be replaced.**

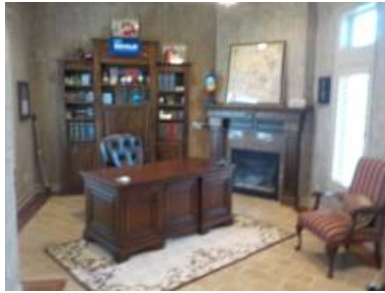
Front Office

Flooring: The floor has no significant defects.
Walls and Ceiling: The walls and ceiling are in acceptable condition.
Window Type: Double Pane.
Window Conditions: The crank mechanism on three of the windows are broken and could not be inspected. recommend repairs or replacement by a certified contractor.
A window is stuck or painted shut and will need service to operate smoothly.

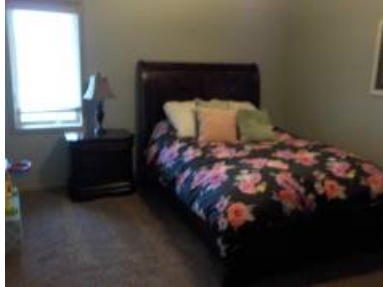
2nd Guest Bedroom

Doors: The door in this room is functional.
Flooring: The floor has no significant defects.
Walls and Ceiling: The walls and ceiling are in acceptable condition.
Window Type: Double Pane.
Window Conditions: The crank mechanism is broken and could not be inspected. Recommend repairs or replacement.

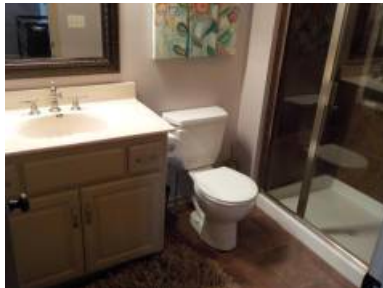
1st Guest Bedroom Bathroom

Walls and Ceiling: The walls and ceiling are in acceptable condition.
Sink(s) and Drainage: The sink is in acceptable condition.
Stall Shower The stall shower is functional.
Toilet: **The toilet is loose, and should be secured. Because the toilet is loose, this lets air reach the wax ring, and can dry out the ring. The likelihood of leaking at the seal is high. We recommend replacing the wax ring at the same time this work is being performed.**

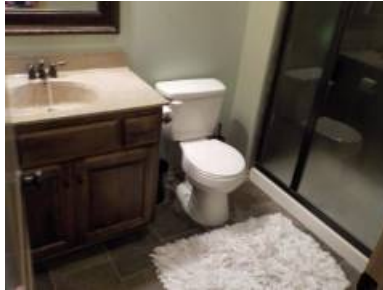
2nd Guest Bedroom Bathroom

Size: This is a full bathroom.
Doors: The door in this room is functional.
Flooring: The floor has no significant defects.
Walls and Ceiling: The walls and ceiling are in acceptable condition.
Sink(s) and Drainage: The sink is in acceptable condition.
Stall Shower The stall shower is functional.
Toilet: **The toilet is loose, and should be secured. Because the toilet is loose, this lets air reach the wax ring, and can dry out the ring. The likelihood of leaking at the seal is high. We recommend replacing the wax ring at the same time this work is being performed.**

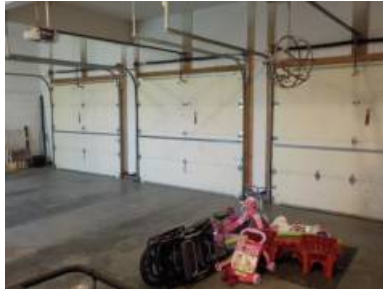
Slab Floor The slab floor is cracked. Such cracks are common and result as a consequence of the curing process, seismic activity, ordinary settling, or the presence of expansive soils and are not structural concerns.

Walls and Ceiling: The walls and or ceiling have stress fractures, which have resulted from movement. Recommend continued evaluation and repairs as needed by a certified contractor.
